STOPBANK PERFORMANCE DURING THE  
2010 – 2011 CANTERBURY EARTHQUAKE SEQUENCE

A thesis submitted in partial fulfilment of the requirements for the Degree  
of Master of Science in Engineering Geology

Sophie Elizabeth Bainbridge

2013

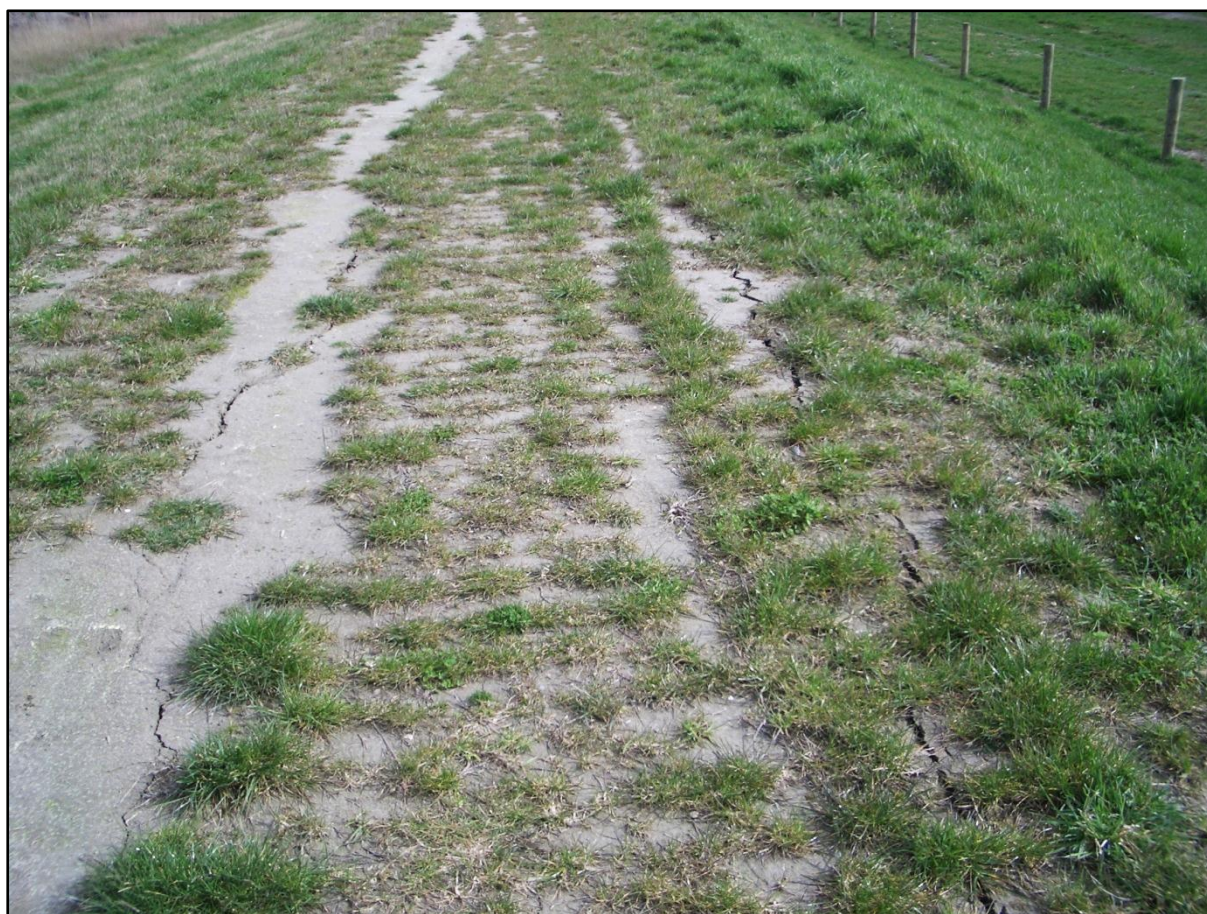
This deformation mode is characterised by minor (less than 20 mm wide) cracks at the shoulder of the stopbank and negligible loss of crest. The cracks do not arc and run parallel with the crest as depicted in Figure 43. This may or may not be associated with liquefaction ejecta at the surface. According to LiDAR this deformation mode occurred for settlements in the range of 0.4 m to 1 m. It is expected that a large amount of this settlement is total rather than differential. The differential settlement is more likely to translate to surface deformations. This is broadly consistent with crest surveys undertaken along the Kaiapoi River, which indicate up to 0.5 m of differential settlement along the length of this deformation mode.

FIGURE 43: EXAMPLE OF MINOR CREST SETTLEMENT (DM2-MCCS). PHOTO PROVIDED BY ENVIRONMENT CANTERBURY.

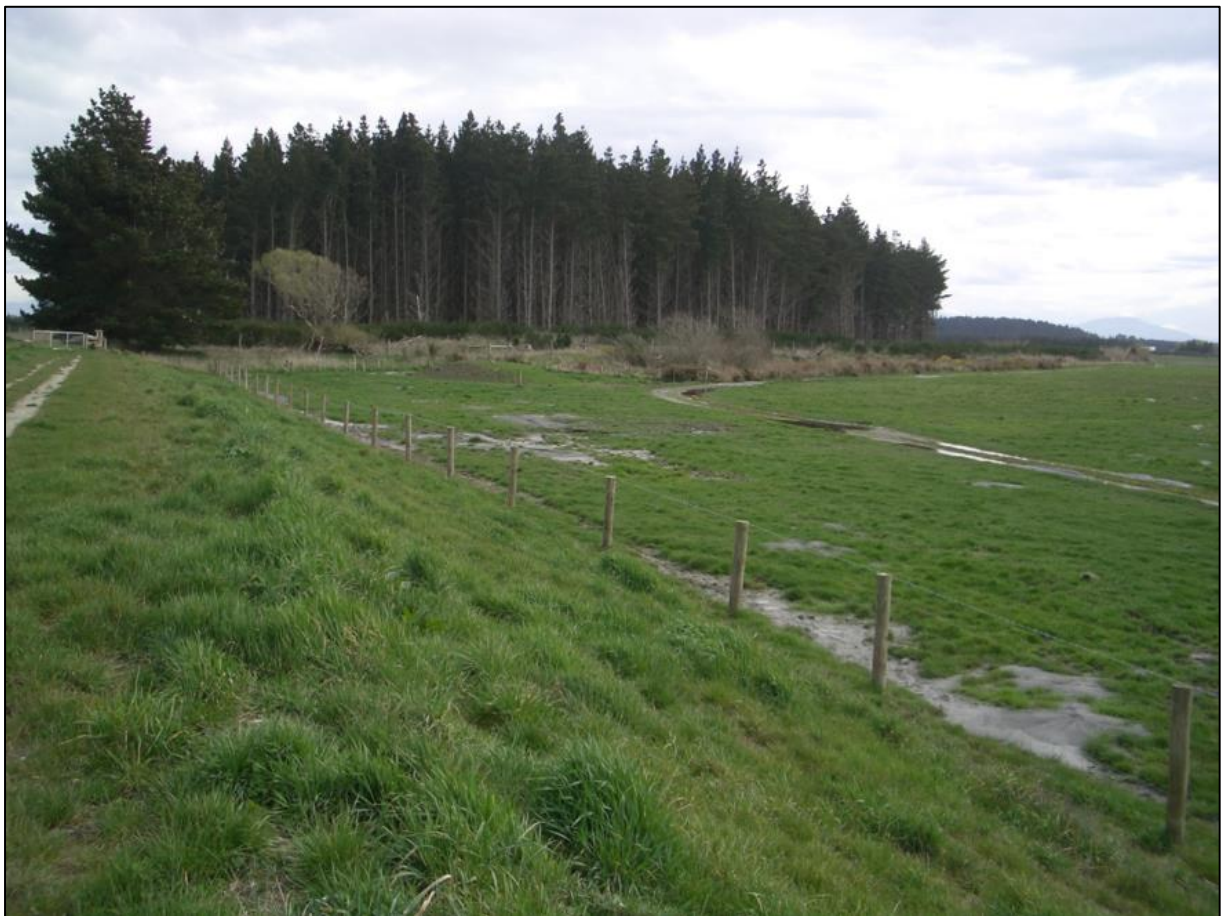
Differential settlement of the stopbank crest is a common deformation mode that occurs both independently and with all of the other deformation modes (Figure 50). This is the most prevalent deformation mode affecting approximately 3.6 km and 3.0 km of the WEC system and the Avon River, respectively.

FIGURE 51: EXAMPLE OF DIFFERENTIAL SETTLEMENT (DM5-DS). PHOTO PROVIDED BY ENVIRONMENT CANTERBURY.

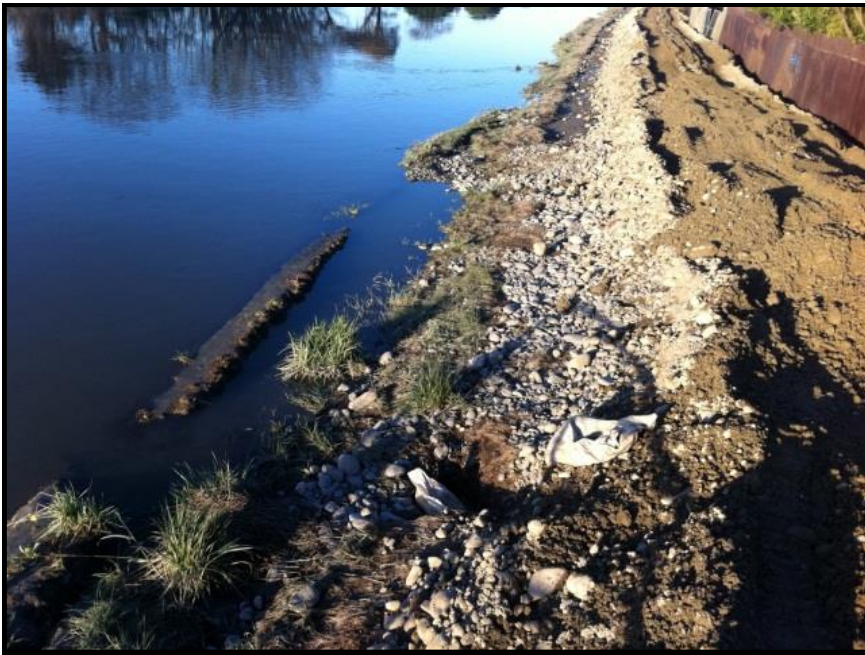
Gabion baskets and reinforced concrete flood protection walls are two common flood protection structures along the Avon River. These engineered structures have deformed due to the earthquakes in two key ways: outward rotation and complete collapse, as shown in Figure 54 through Figure 57. Approximately 100 m of the WEC system and 5400 m of the Avon River were affected by this mechanism.

**FIGURE 57: COLLAPSE OF GABION BASKET AND SUBSEQUENT SLUMPING OF LAND INTO ACCOMMODATION SPACE**

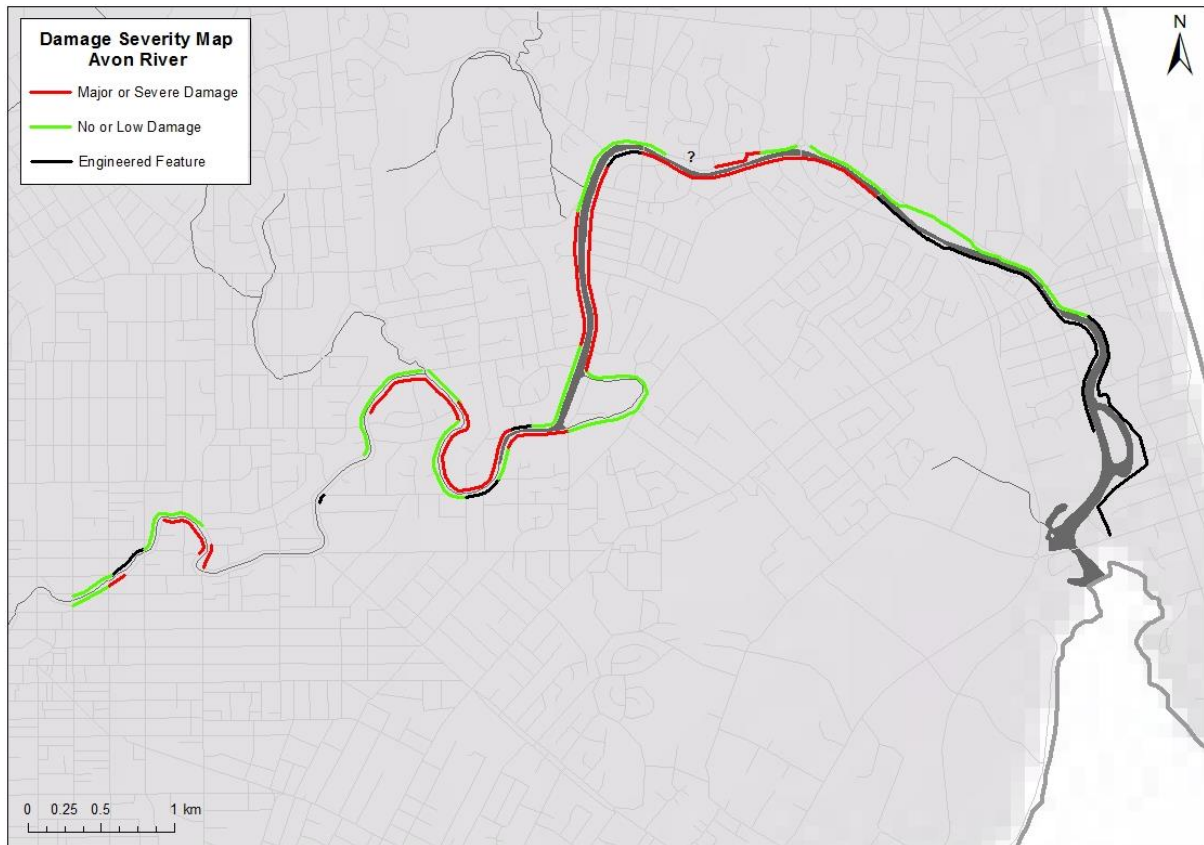
FIGURE 61: DAMAGE SEVERITY MAP - AVON RIVER

The deformation mode observations outlined in Chapter 5 have been used to classify the stopbank systems in terms of damage severity. This has been done in order to segregate the areas that have suffered no to low damage against the areas that have suffered major to severe damage to delineate factors that differentiate between the level of severity that will occur at any given site. The criteria for dividing up these areas are described in Table 17. The distribution of the severity classification for the Avon River is illustrated in Figure 61 and for the WEC system in Figure 62.

The role of lateral spreading in the case of the Avon River is directly relevant to river morphology. As shown in Figure 61 the majority of the major to severe damage occurred within the meandering loops (the point bar) whereas the low or no damage zones are often located on the outside of the loops (the cut bar). The distribution for each of these locations is shown in Figure 75 for areas where no damage was observed and areas where damage was observed. These pie charts show that at every test location, within the point bar deposit on the river there was some observed damage, and where there was no observed damage the stopbank was constructed on either the cut bank slope or on a straight edge of the river.

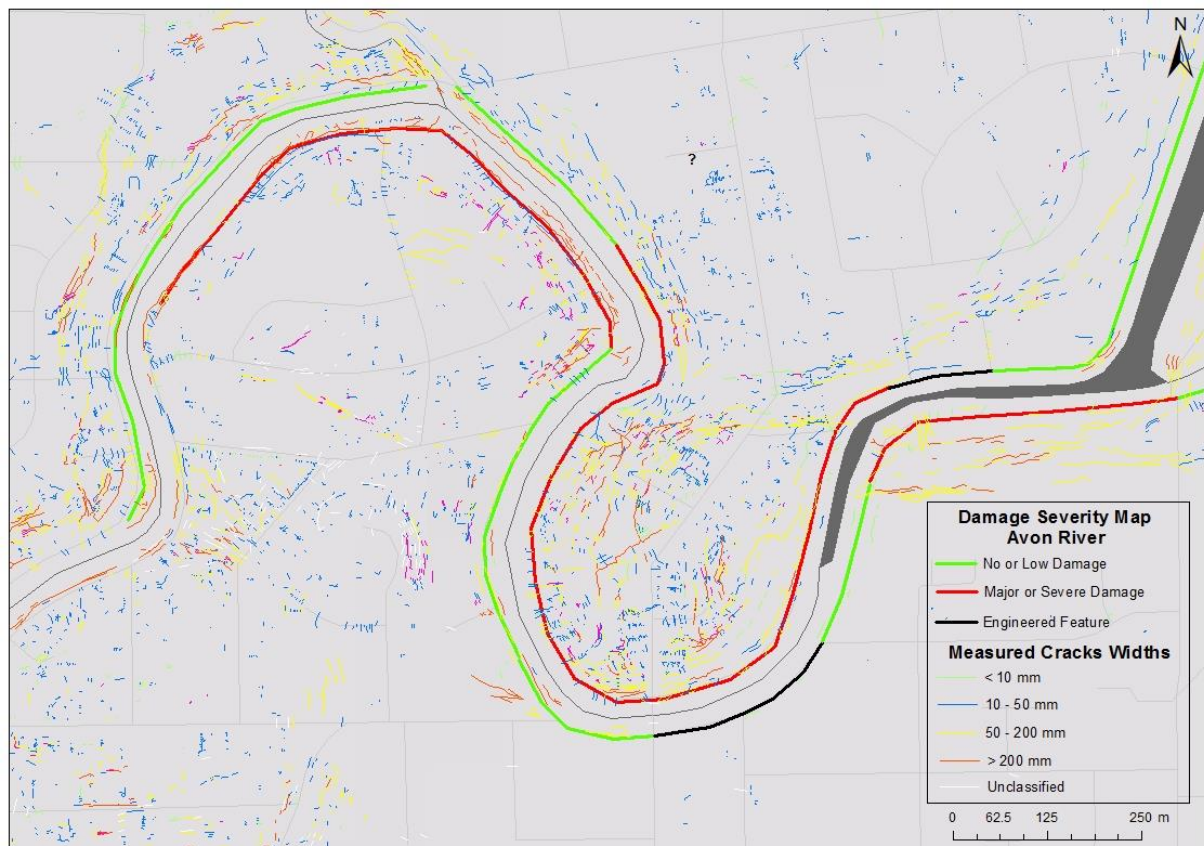
FIGURE 72: LOCATION OF CRACKS IN RELATION TO DAMAGE SEVERITY

Lateral stretch and spread was commonly associated with major to severe stopbank damage. As shown in Figure 72 cracks with width of greater than 200 mm are commonly associated with the major or severe damage zones, whereas there are generally fewer and narrower cracks adjacent to the no or low damage zones.

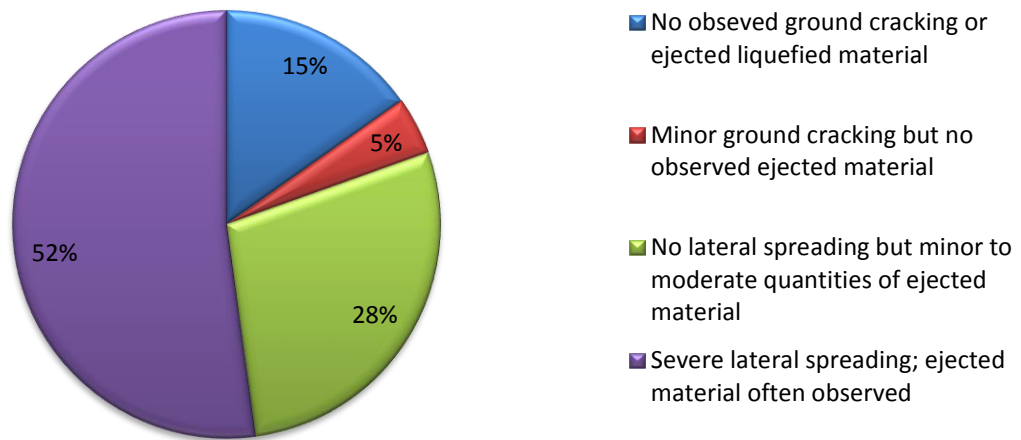
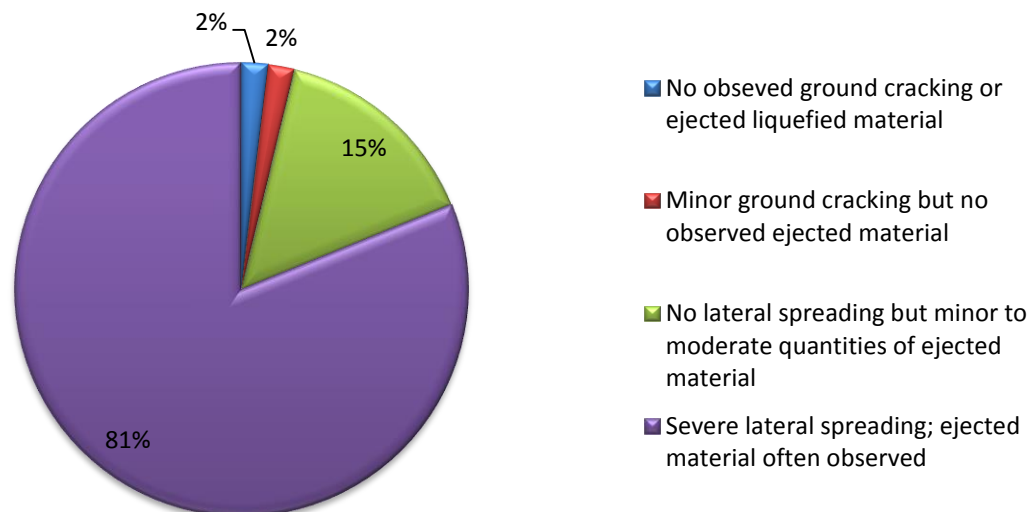
FIGURE 73: EQC LIQUEFACTION AND LATERAL SPREADING OBSERVATIONS IN AREAS OF A) NO OR LOW DAMAGE AND B) MAJOR OR SEVERE DAMAGE OF STOPBANKS

Property based EQC observations indicating areas which suffered lateral spreading induced damage verses areas that suffered only liquefaction induced damage can be compared with stopbank severity to demonstrate that the severity is often due to lateral spreading rather than just liquefaction alone. This is preliminary as the observations are property based, and therefore not directly adjacent to the river. They show that areas which suffered no or low damage there was a 57% likelihood of suffering some form of ground cracking as defined by the EQC, compared to an 83% likelihood in the areas that are classed as major or severe damage, as shown in Figure 73. This indicates that there are areas where the native ground suffered extensive damage that was not reflected in the stopbank system.

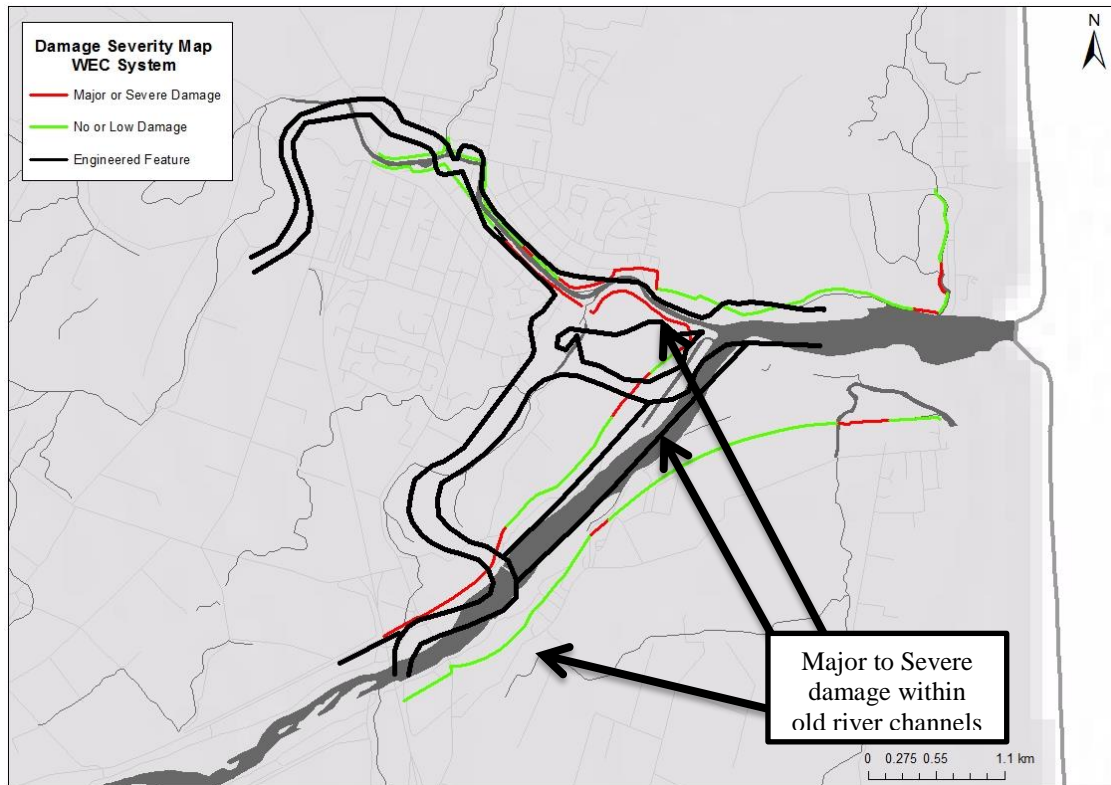
**FIGURE 74: DAMAGE SEVERITY MAP FOR THE WEC SYSTEM SHOWING LOCATION OF ABANDONED RIVER CHANNELS**

The presence of abandoned river channels beneath the stopbank is a key indicator for damage along the WEC system where there has been extensive anthropogenic modification of the river system. As shown in Figure 74 major or severe damage correlates well with the presence of abandoned/old river channels. As mentioned previously, according to Wotherspoon et al. (2011) the areas underlain by old river channels in the Kaiapoi area were subject to some form of liquefaction, and in most areas however liquefaction and/or lateral spreading were significant.

A review has been undertaken of relevant geomorphological digital elevation models, for example the one presented in Figure 5 of Chapter 2, which may provide more information into smaller paleochannels that existed around the Kaiapoi and Waimakariri River. The review indicates that as well as the locations of the abandoned river channels shown in Figure 74 there are many other smaller channels which coincided with the other locations that have suffered major to severe damage. Therefore, it is reasonable to conclude that all of the major to severe damage observed to the stopbank system in Kaiapoi and Waimakariri was within or directly adjacent to an abandoned river channel. Furthermore, a small portion of areas with no to low damage occurred within the abandoned river channels.

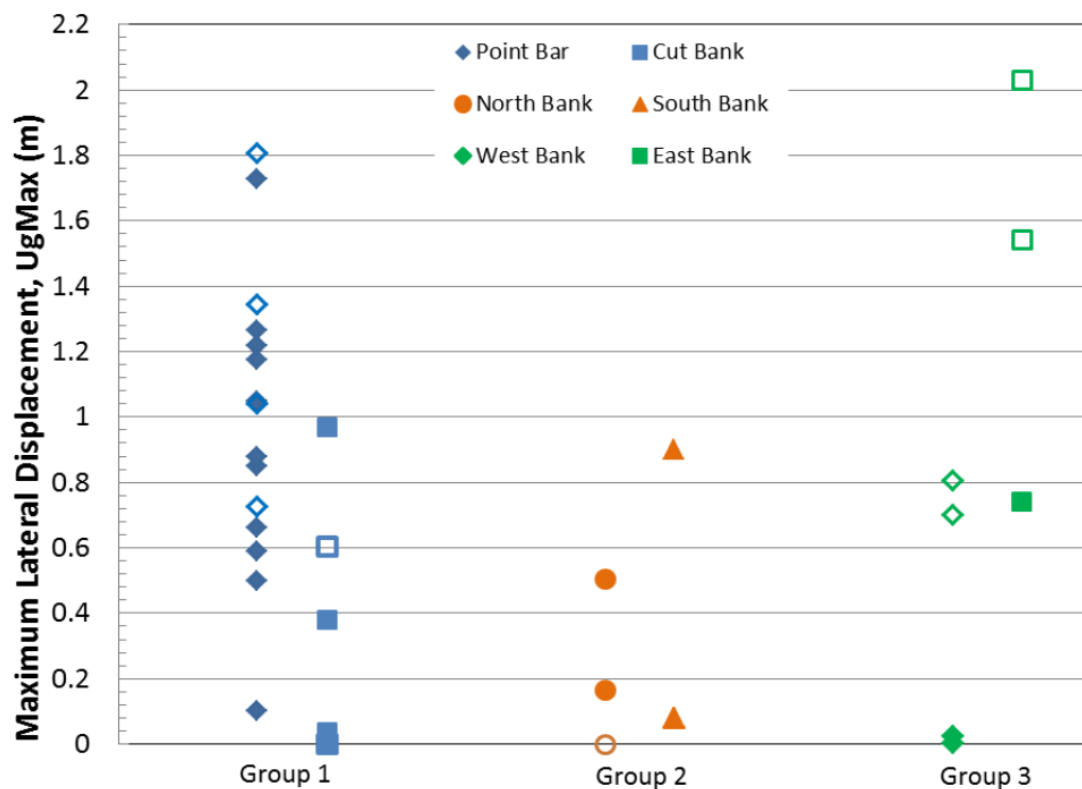
FIGURE 76: COMPARISON OF LATERAL SPREADING MEASUREMENTS WITHIN SPECIFIC AREAS ALONG THE AVON RIVER (SOLID SYMBOLS CORRESPOND TO 4 SEPTEMBER 2010 DATA, HOLLOW SYMBOLS CORRESPOND TO 22 FEBRUARY 2011 DATA); TAKEN FROM ROBINSON ET AL., 2012.

Robinson et al. (2012) explored this phenomenon further by computing maximum lateral displacements from transects within the point bar area and cut bank area of the Dallington/Avonside loop. As shown in Figure 76 the point bar data indicates a maximum horizontal displacement of about 1.8 m and an average of approximately 1.0 m; while the cut bank data shows a maximum of about 1 m and an average of only 0.3 m. The differences in the observed horizontal displacements can be attributed to the contrast in soil conditions characteristic of the depositional setting. As the river meanders downslope the point bar is deposited as the water cuts into the opposite bank due to its higher velocity at this point. Point bars are composed of sediment that is well sorted, loose and fine grained. They also have a very gentle slope and an elevation very close to water level meaning that the sediments are saturated closer to the water surface.

The other key factor that influences lateral spreading at these locations is the stresses acting on the soil due to the geometry. Within the meander the soil movement toward the river produces tensile stresses that create ground cracking. Conversely, at the cut bank the movement towards the river causes compressional stresses.

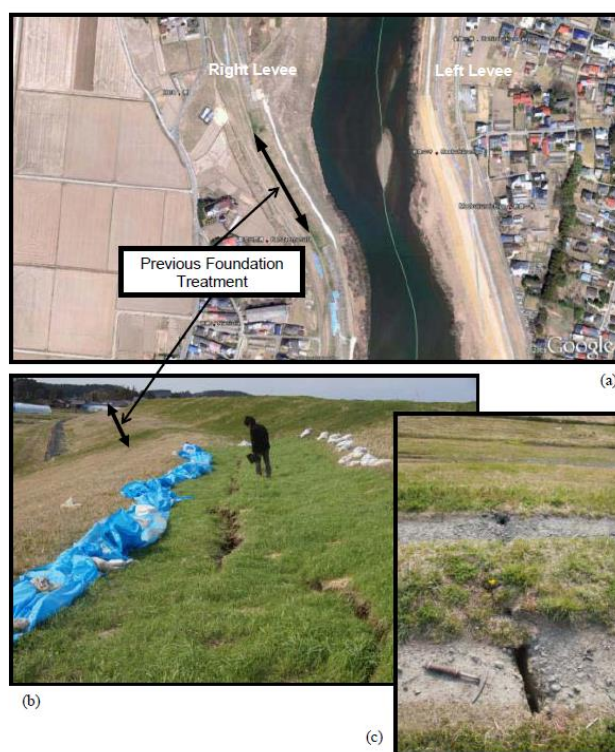
Severe stopbank damage was recorded at multiple sites along the Naruse River in response to the Tohoku earthquake. Two of the treated sites had moderate liquefaction related stopbank damage directly beyond the limits of the ground treatment. In some cases, this resulted in transverse cracking at the interface between treated and non-treated sections of the stopbank. Takahashi & Sugita note that although the cost of these treatments was probably significant, it was successful in preventing major liquefaction-related damage.

Figure 2: (a) Aerial view of treatment area (adapted from Google Earth, 2011), (b) Longitudinal cracking and clumping of waterside stopbank slope downstream of treatment area, and (c) transverse cracking on stopbank crown at downstream edge of treatment area on Naruse River right stopbank (GEER Association Report No. GEER-025b)

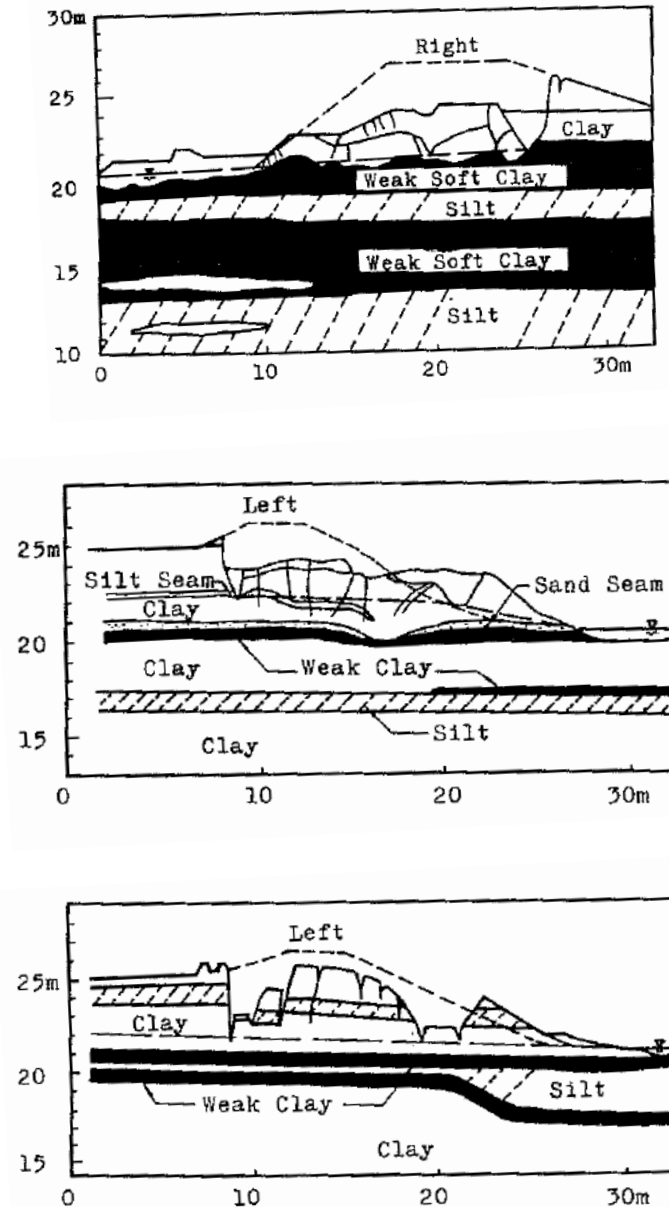
Slope failure due to weakness in soft clayey soils interbedded with thin layers of sands and silts occurred during the March 8 earthquake. The slope failures presented in Figure 4 are due to slippage on ‘weak materials’, namely materials with very low undrained shear strength (parameters as low as  $\phi = 6.5^\circ$  and  $c = 5$  kPa). Of note is that the foundation soils did not liquefy in the case of slope failure, rather the failure occurred in the weak soft clay layers.

FIGURE 4: SLOPE FAILURE OF BANK AND STOPBANK IN FUYANG RIVER DUE TO SLIPPAGE ON (A) A THICK SOFT CLAY LAYER; (B) A THIN WEAK CLAY LAYER JUST BELOW A THIN SAND SEAM, AND (C) THIN WEAK CLAY LAYERS ADJACENT TO A THIN SILTY SEAM

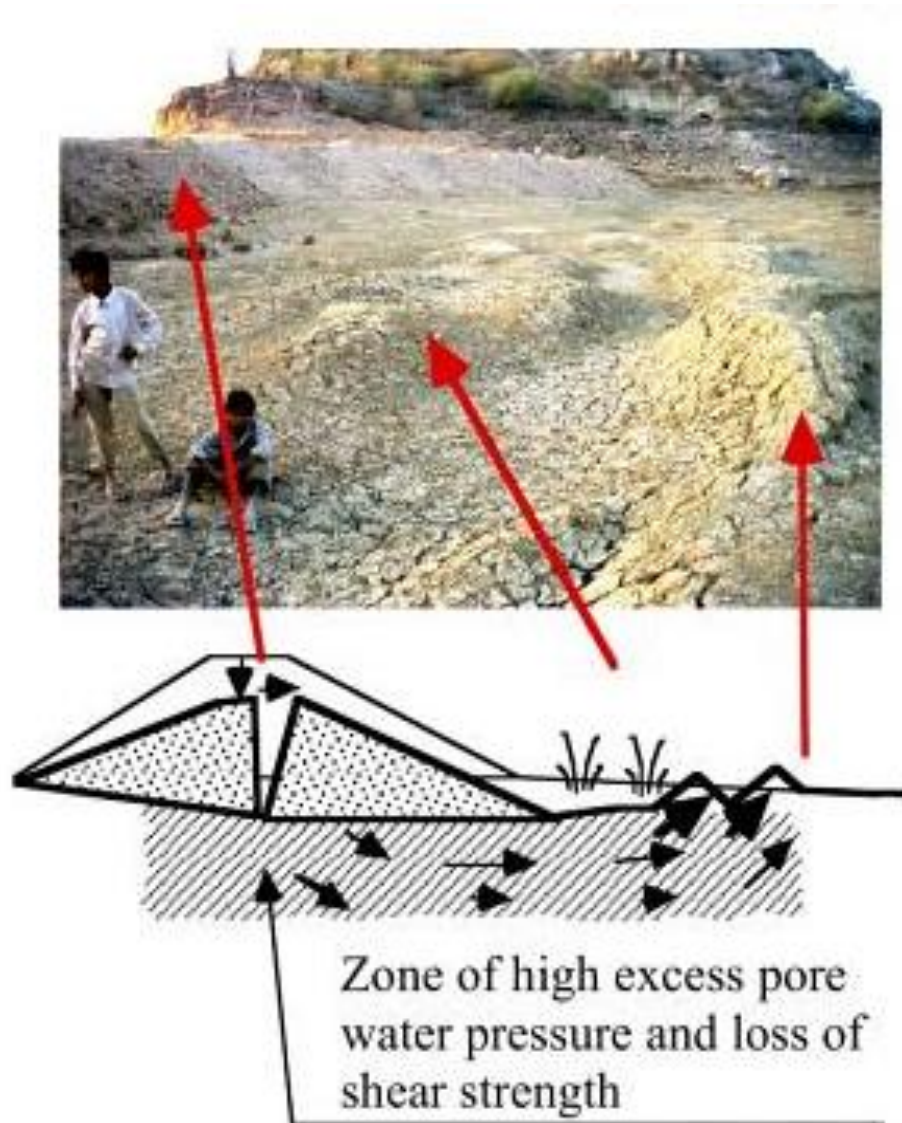
FIGURE 6: GROUND DEFORMATION IN SOFT FOUNDATION SOILS OF THE CHANG DAM (TOWHATA ET AL., 2002)

The presence of loose liquefiable materials through old river beds was associated with damage of longitudinal cracking in the dam. The solid bedrock foundation was attributed for the lack of damage. Although liquefaction and sand boiling was found at many places, these observations did not always accompany damaged fills. This indicates that some localised failures were not due to liquefaction of underlying foundation materials, but due to softening of the clay and silt layers and preferential sliding planes within these layers.

Subsidence, cracking and lateral spreading in overlying artificial fills is inferred to have been caused by a reduction of shear strength in the materials beneath the dam triggering a slope movement of soil and lateral spreading (including cracking of the dam body). Towhata et al. (2002) concluded that large distortions of the fills are associated with soft natural subsoils: *‘The amplification of seismic motion upon the soft subsoil as well as possibly the cyclic and residual deformation of this soft soil induced the damage to the dam body.’* It is suggested that subsoil improvement is key to avoiding repetition of similar damage during future earthquakes.

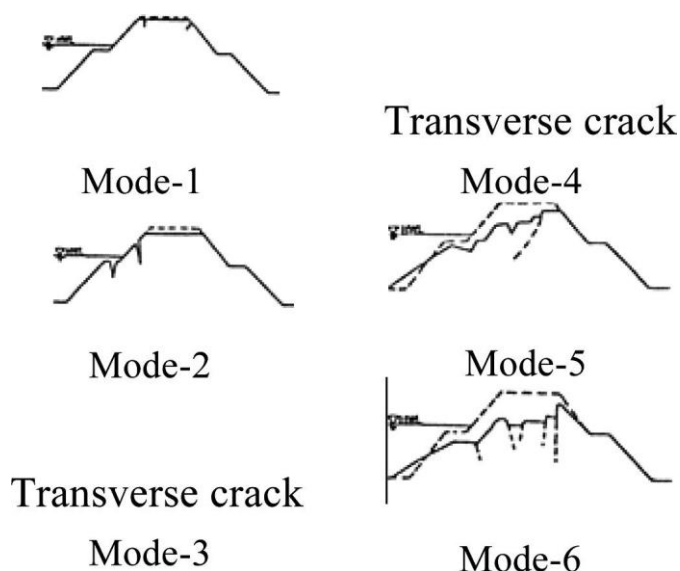
FIGURE 7: STOPBANK FAILURE MODES ALONG THE TOKACHI AND KUSHIRO RIVERS (SASAKI, 2009)

Over 26 km of stopbanks were damaged along various rivers due to the  $M_w 7.8$  earthquake. Damage was varied along this length with both vertical and horizontal settlements apparent along the river that mirrored ground deformation (Sasaki, 2009). Figure 7 illustrates the typical view of the failed stopbank along the Kushiro River, with typical cross sections shown in Figure 8.

This settlement had two important effects. First it brought the lower part of the sand fill below the water table that existed at the time of the earthquake. This created the potential for liquefaction in the fill. Secondly, the large settlement caused a redistribution of stresses in the lower part of the stopbank. The stretching and arching of the stopbank reduced the confining stresses in the saturated region of the fill. It is considered that the saturated base of the stopbank was liquefied and this triggered the stopbank failure. This is supported by the observed fact that the amounts of subsidence at the stopbank crest during the earthquake increased with the amounts of consolidation of the peat deposits. Similar failure modes were seen following the  $M_w 9.0$  Tohoku earthquake in March 2011 (Harder et al., 2011).

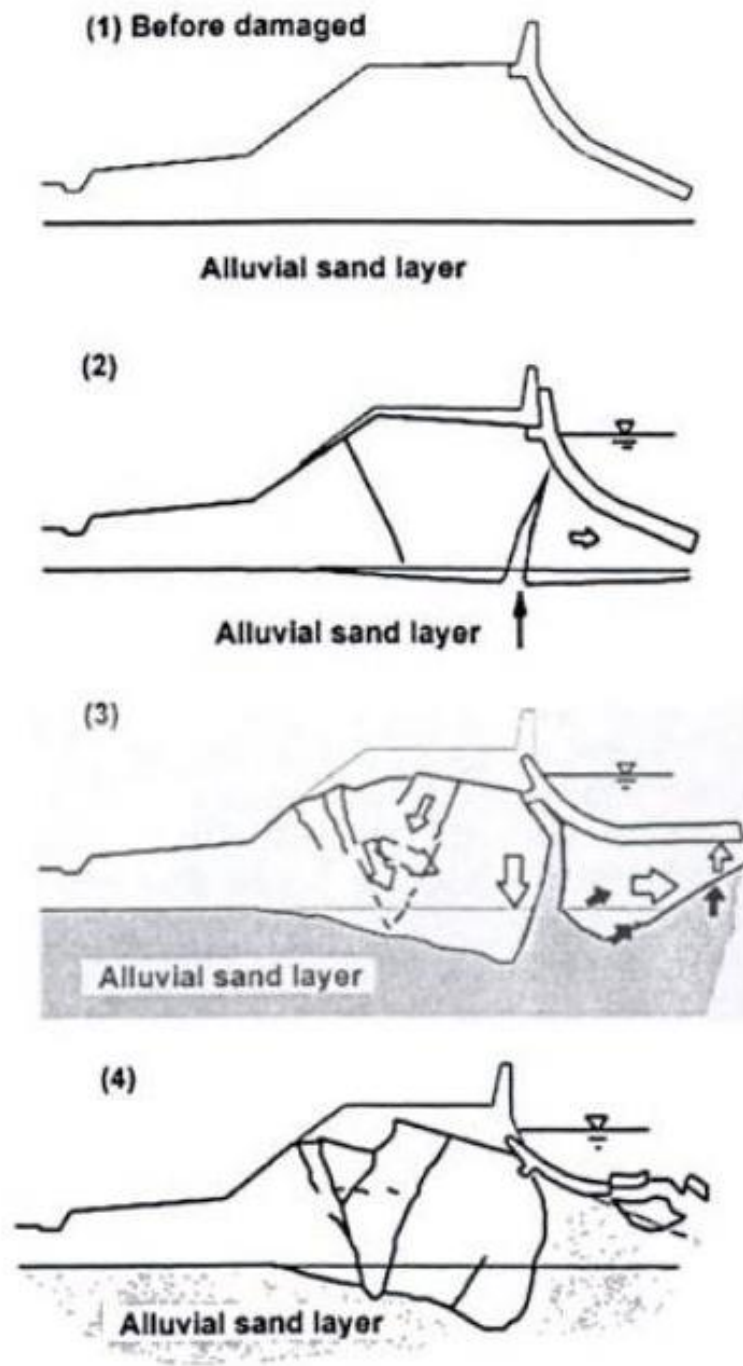
FIGURE 12: FAILURE PROCESS AT THE DAMAGED TORISHIMA STOPBANK (SASAKI AND SHIMADA, 1997)

The failure process of the damaged stopbank at the Torishima section as described by Sasaki and Shimada (1997) and depicted in Figure 12 is summarised below:

- 1) Alluvial sandy soil beneath the stopbank was liquefied by earthquake shaking.
- 2) With the raised pore water pressure in the underlying layer, the stress state in the stopbank became active (Rankine state) and a crack developed around the shoulder.

- 4) Because the ground surface was lower and there was a non-liquefied surface layer, and the parapet provided additional weight, the water side portion of the stopbank subsided and the rest of the stopbank was sheared towards the water side.

- 5) Sand boils intruded into cracks while subsidence proceeded and thrusting was continued.
- 6) With the lessening of the raised pore pressure, movement of the soil blocks ceased although deformation of the stopbank remained.

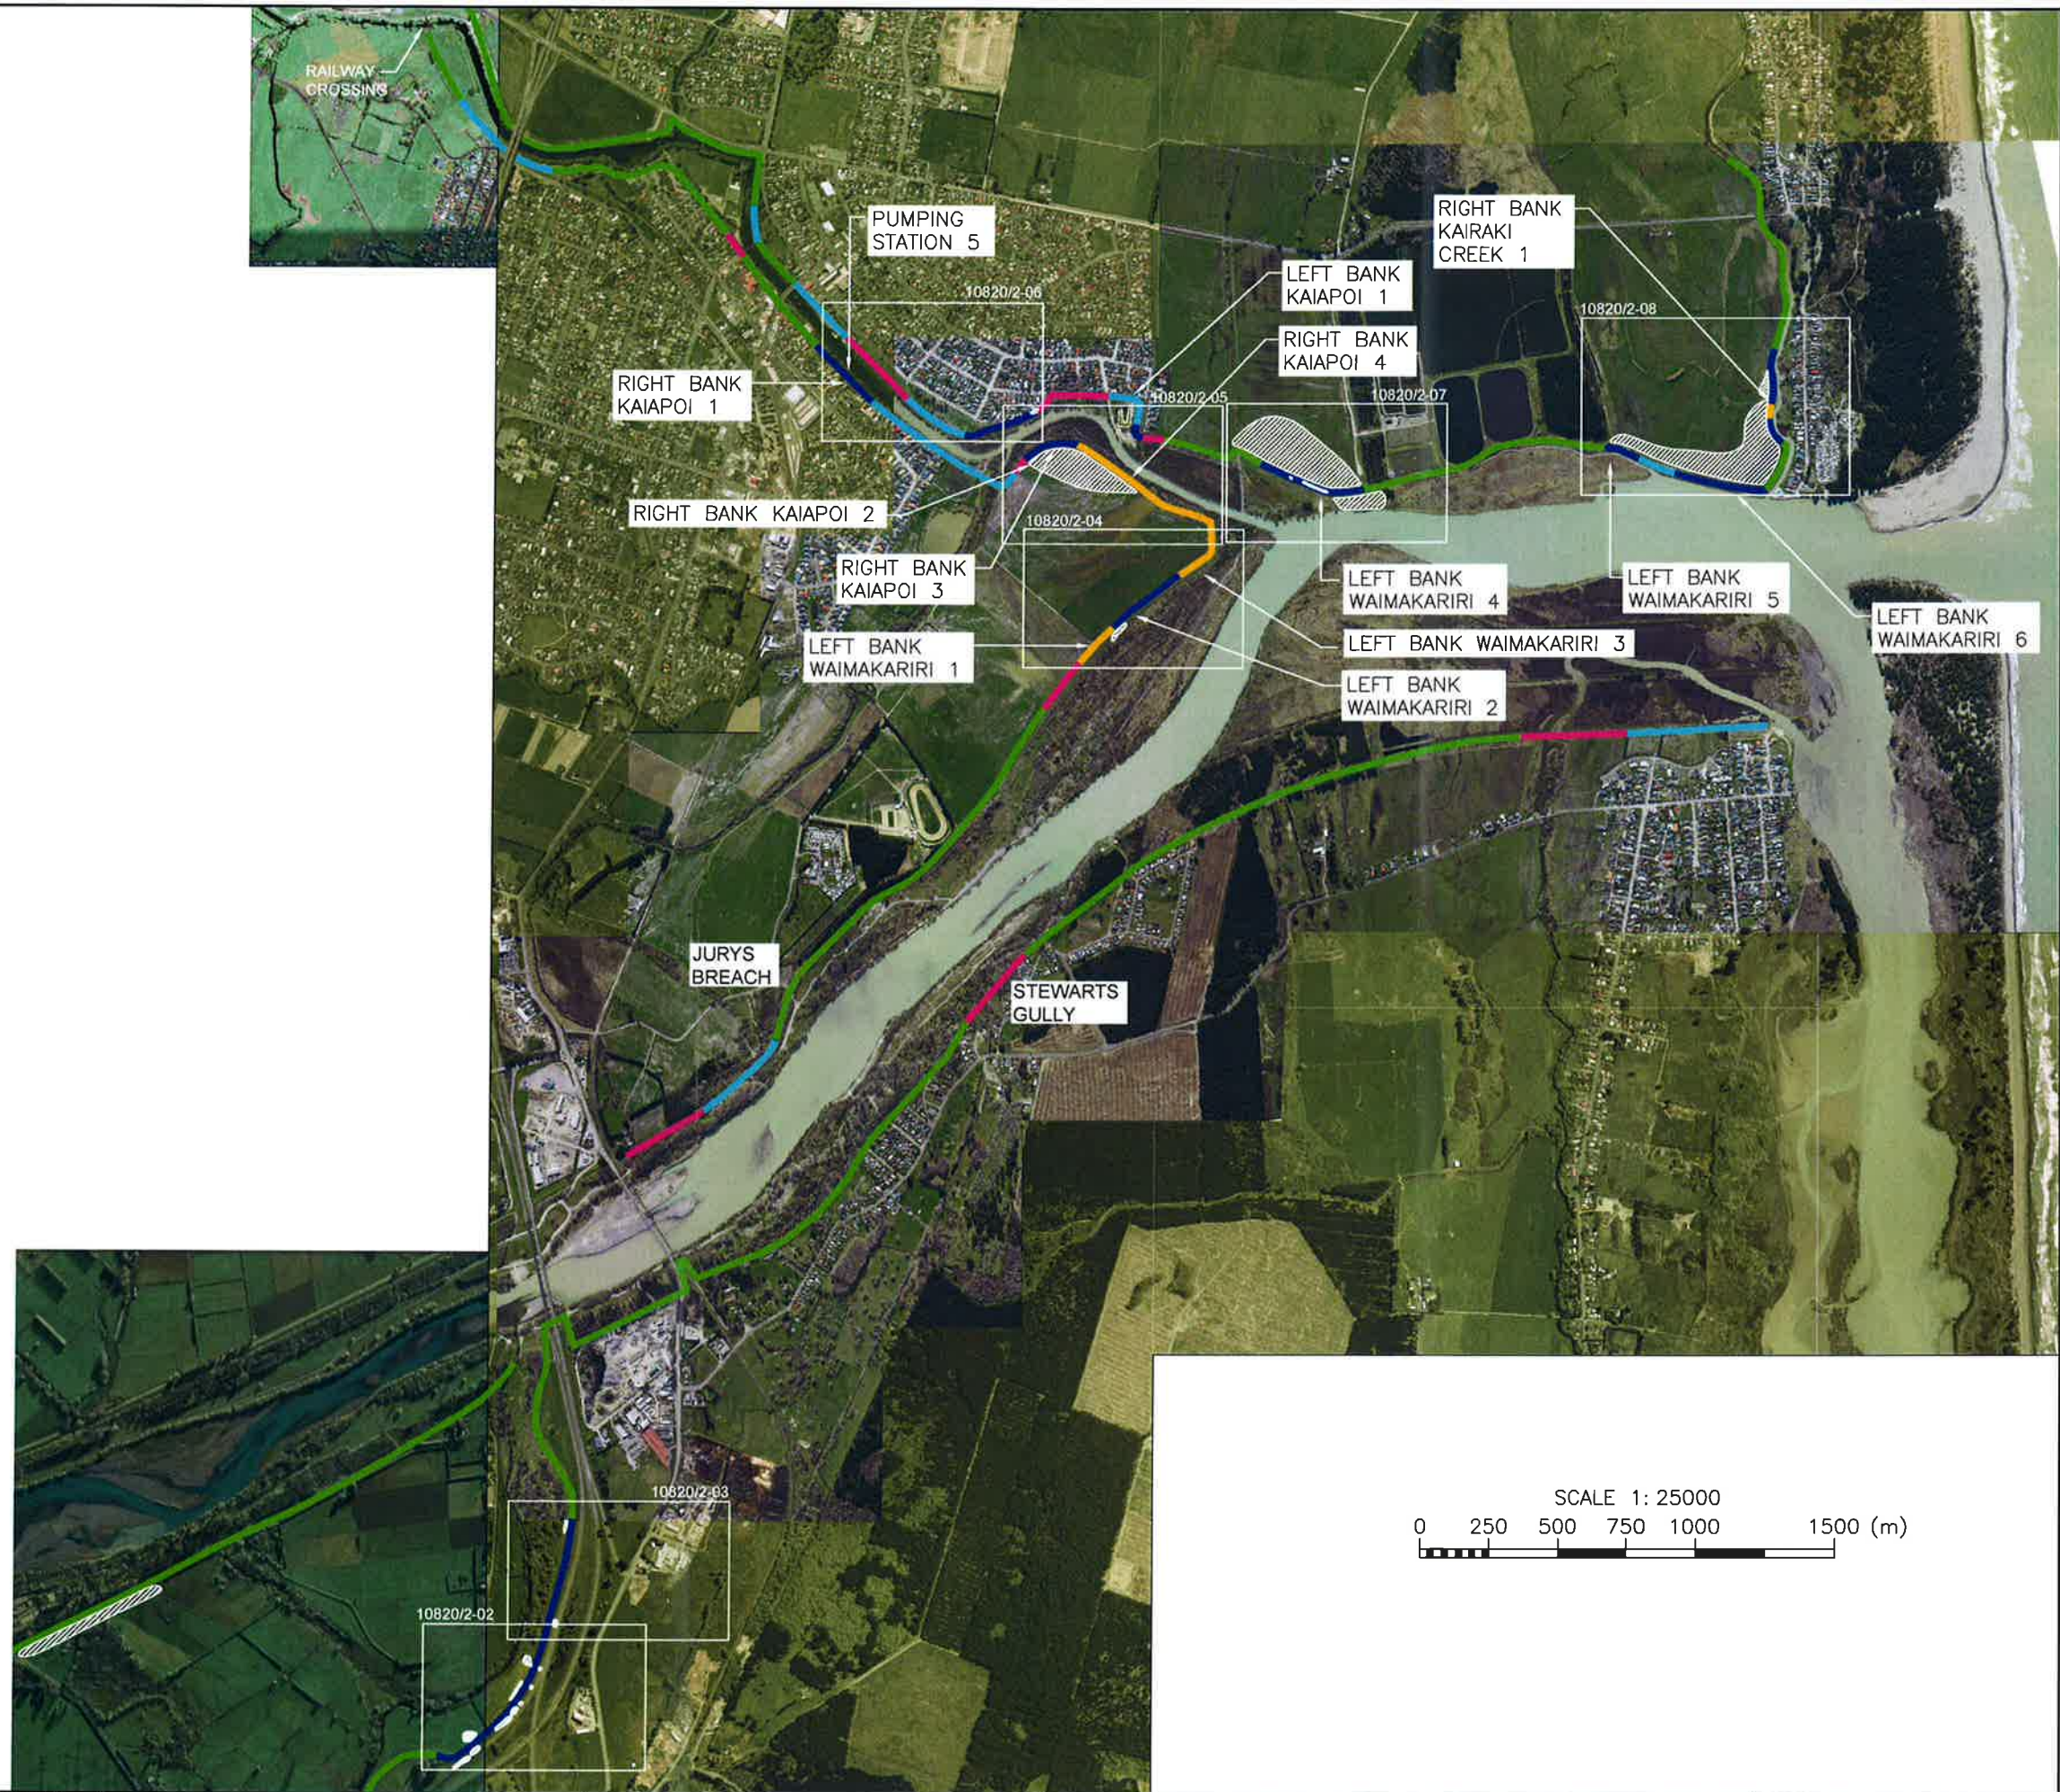
- ZONE 1: NO DAMAGE
- ZONE 2: MINOR:  
CRACKS <5mm WIDE,  
30-140mm DEEP WITH  
NEGLECTIBLE SETTLEMENT
- ZONE 3: MODERATE:  
CRACKS 400mm-1m DEEP  
WITH SOME SETTLEMENT
- ZONE 4: MAJOR:  
CRACKS >1m DEEP. DEEP  
SEATED MOVEMENT &  
SETTLEMENT
- ZONE 5: SEVERE:  
LARGE SCALE INSTABILITY,  
SPREADING & GROSS  
SETTLEMENT >500mm
- ZONE 6: AREAS OF RECENT  
OR CURRENT REPAIRS
- AREAS OF MAJOR  
LIQUEFACTION

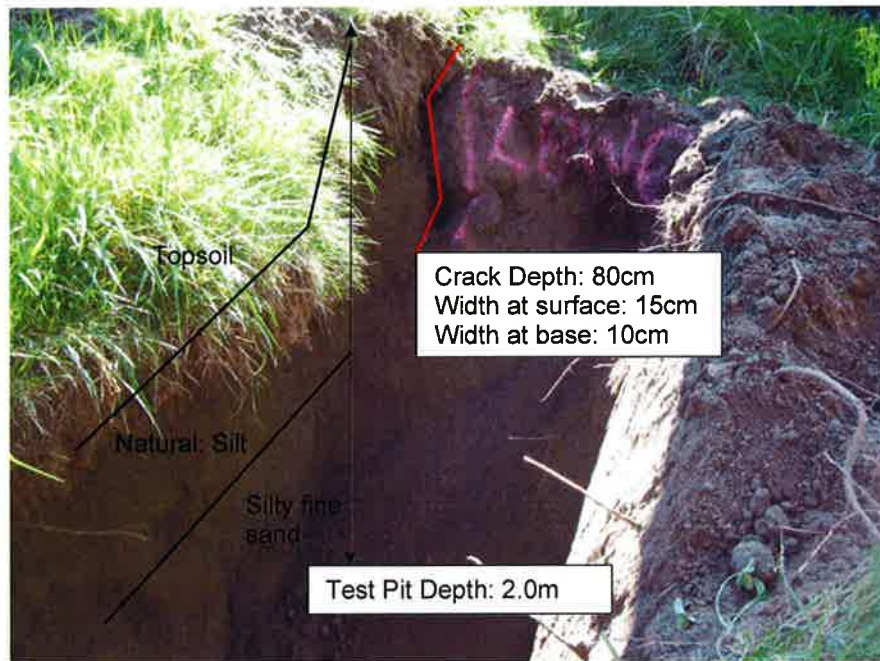
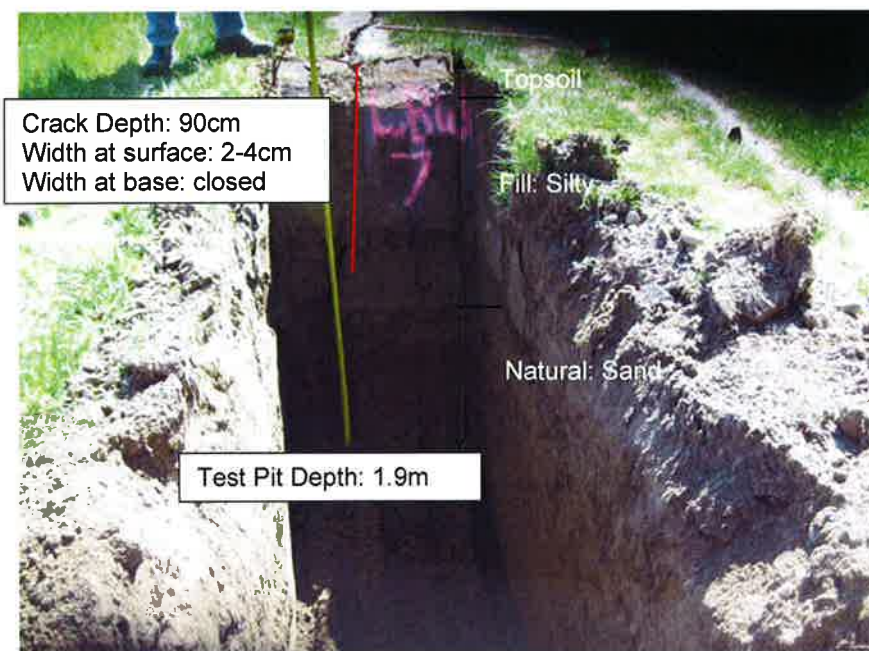
### Test Pit Photos Left Bank Waimakariri (LBW) 4 and 5

Note: 2 Excavated on river side slope of LBW
